**MARYLAND HISTORICAL TRUST
DETERMINATION OF ELIGIBILITY FORM**

Property Name: Smith Farm (Jefferson View Farm) Inventory Number: F-2-111
Address: 3630 Jefferson Pike City: Jefferson Zip Code: 21755
County: Frederick USGS Topographic Map: Point of Rocks, MD and VA
Owner: Jefferson Valley, LLC Is the property being evaluated a district? ☐ yes
Tax Parcel Number: 120 Tax Map Number: 84 Tax Account ID Number: 315780
Project: _____ Agency: _____
Site visit by MHT Staff: ☒ no ☐ yes Name: _____ Date: _____
Is the property located within a historic district? ☐ Yes ☒ no

Photo Log

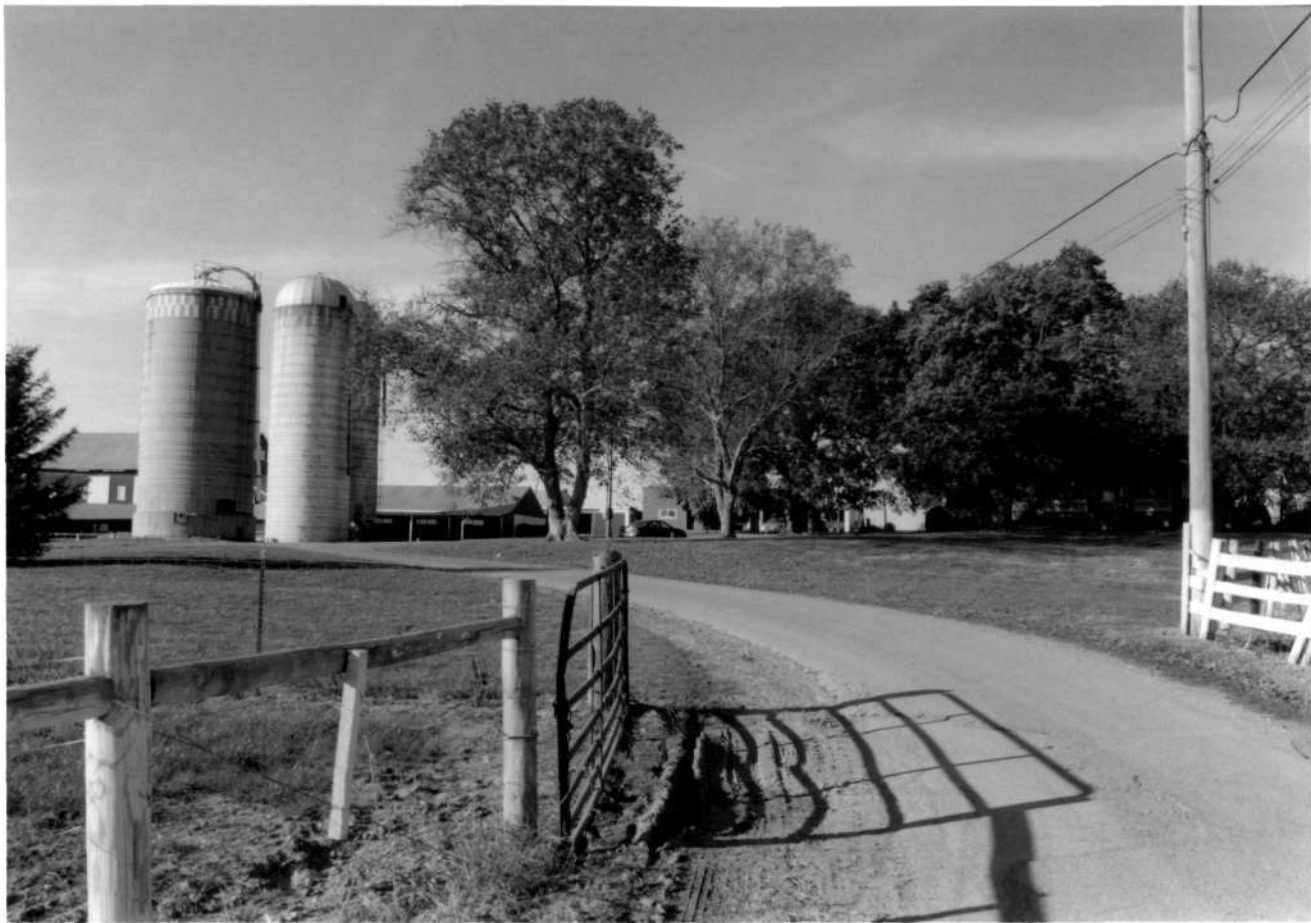
F-2-111
SMITH FARM
FREDERICK COUNTY, MARYLAND
K. PEELER
NOV 645
MD SHED
SETTING, LOOKING NORTH
1 OF 15

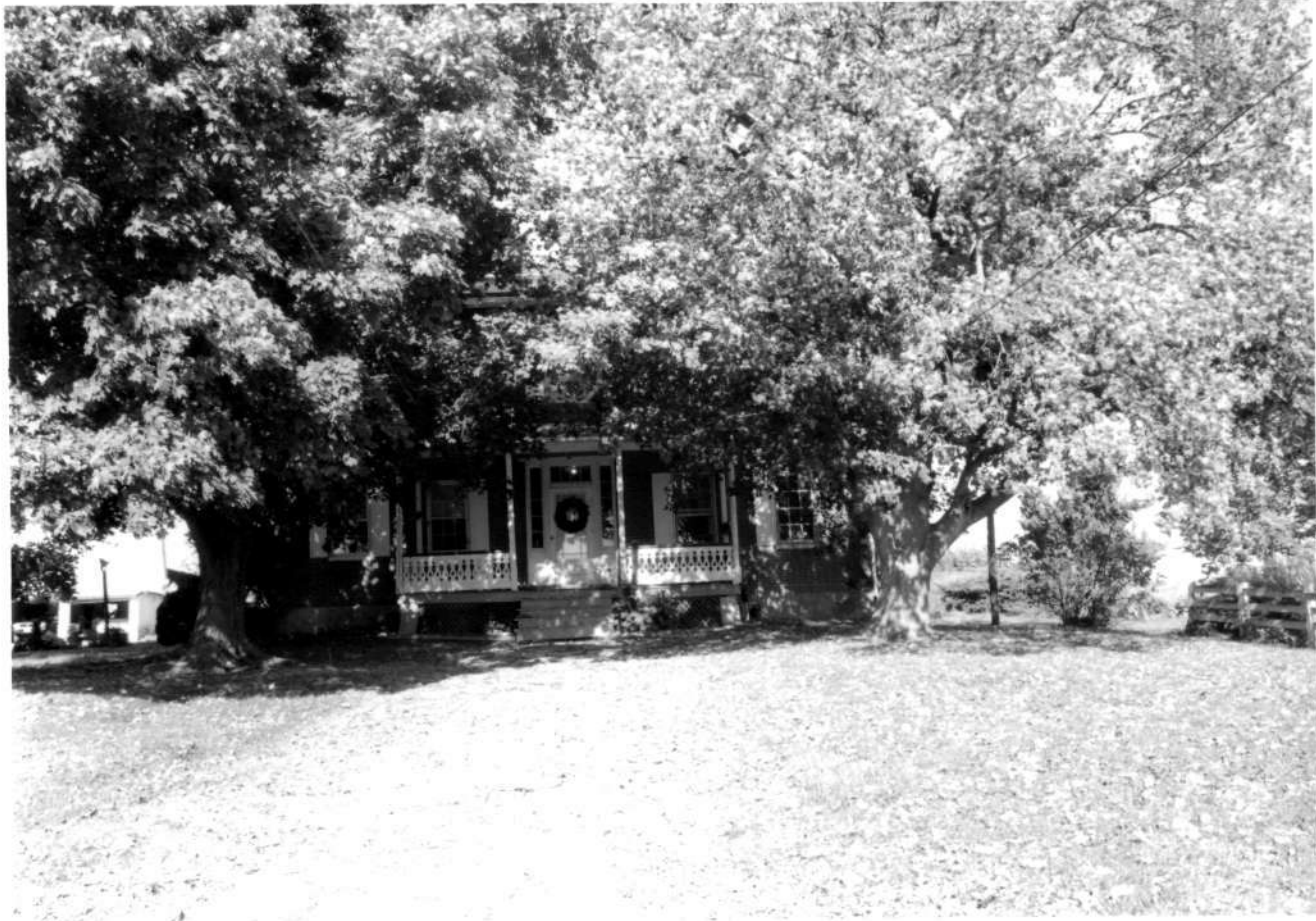
205 15

DWELLING SOUTH ELEVATION

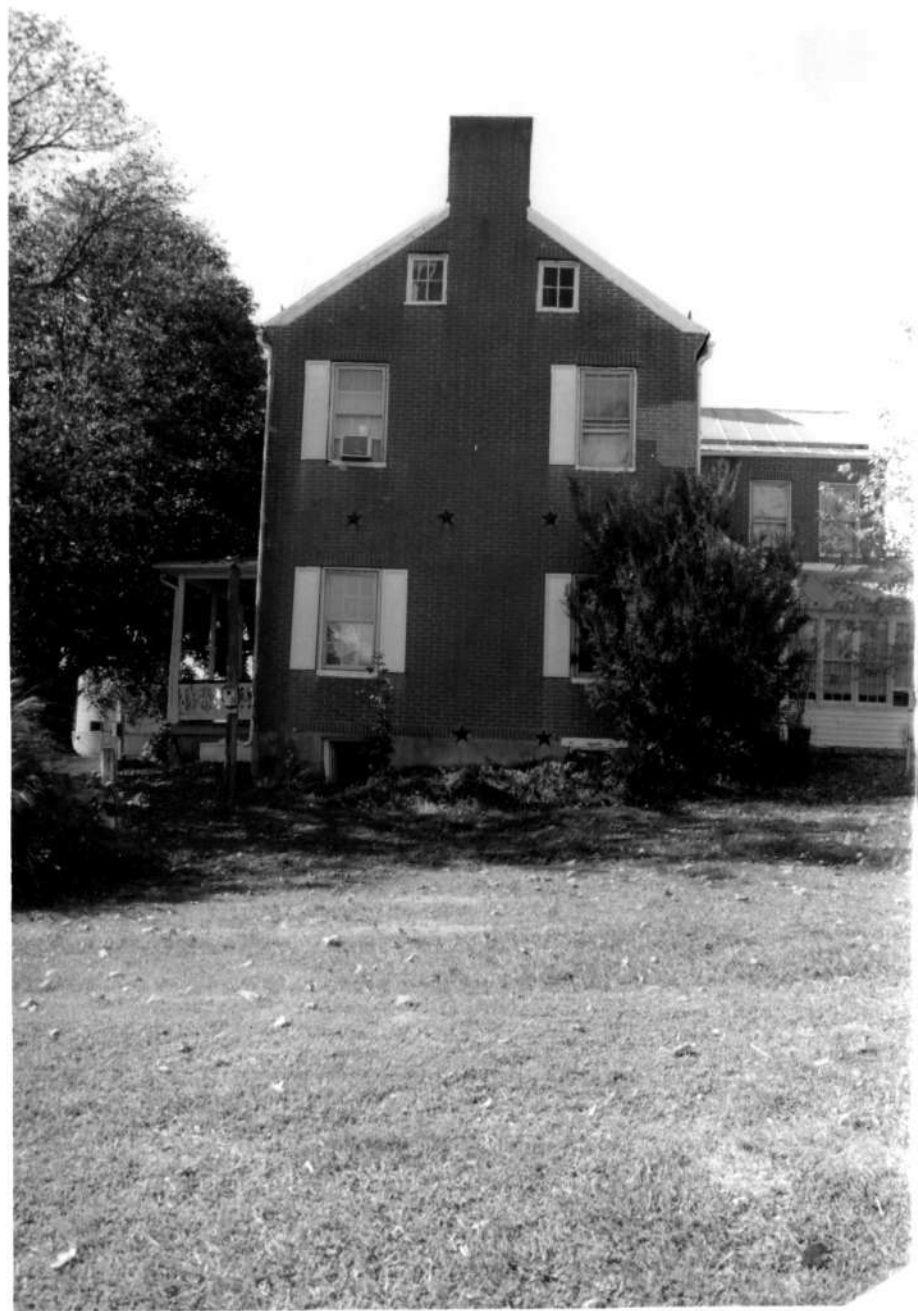
F. 2-111
SMITH FARM
FREDERICK COUNTY, MARYLAND
K. PEELER
NOV 2005
MD SHPO
Duckworth - East Elevation
3 of 15

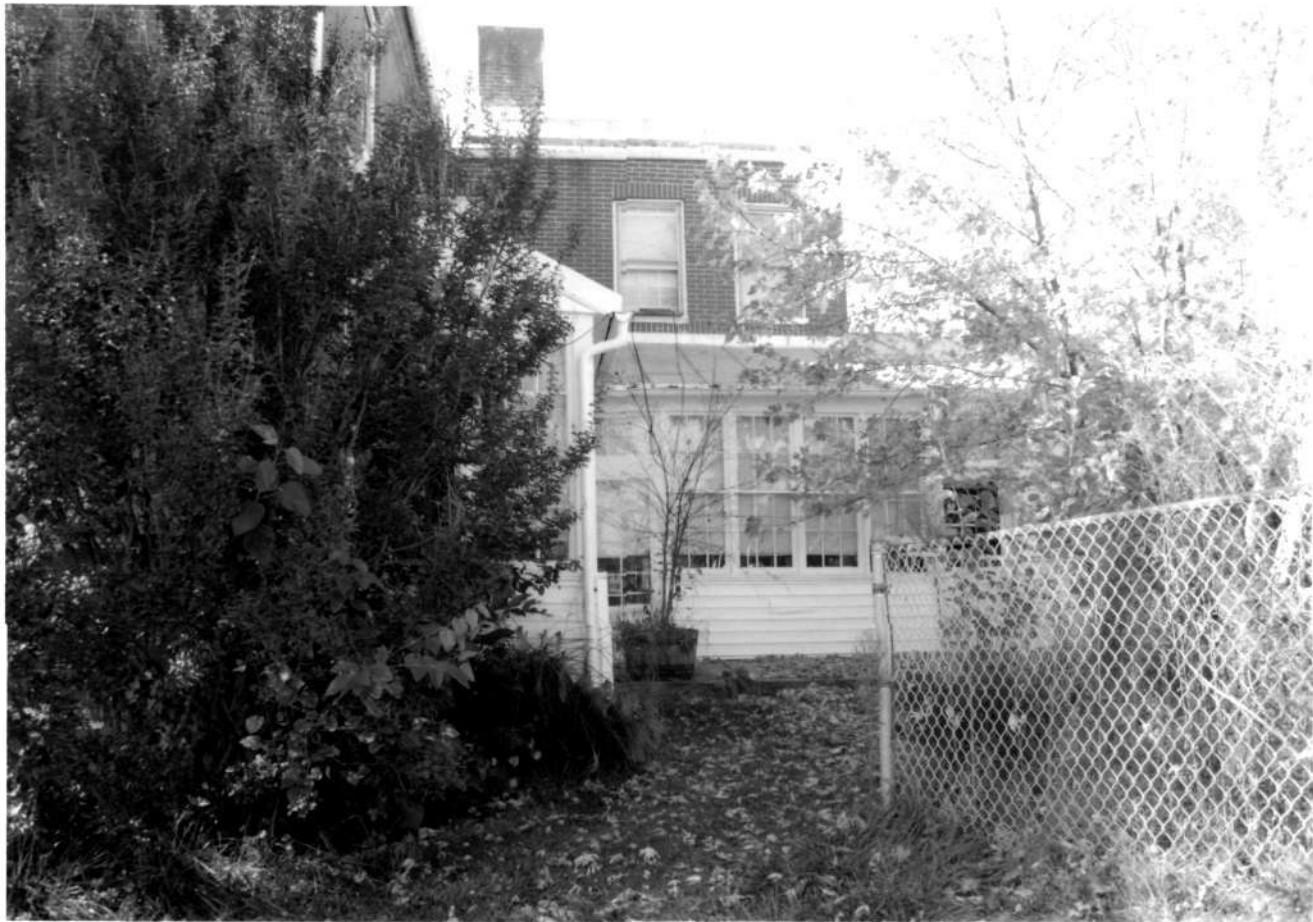
4 OF 15

DWELLING - EAST ELEVATION, ELL & ENCLOSED PORCH

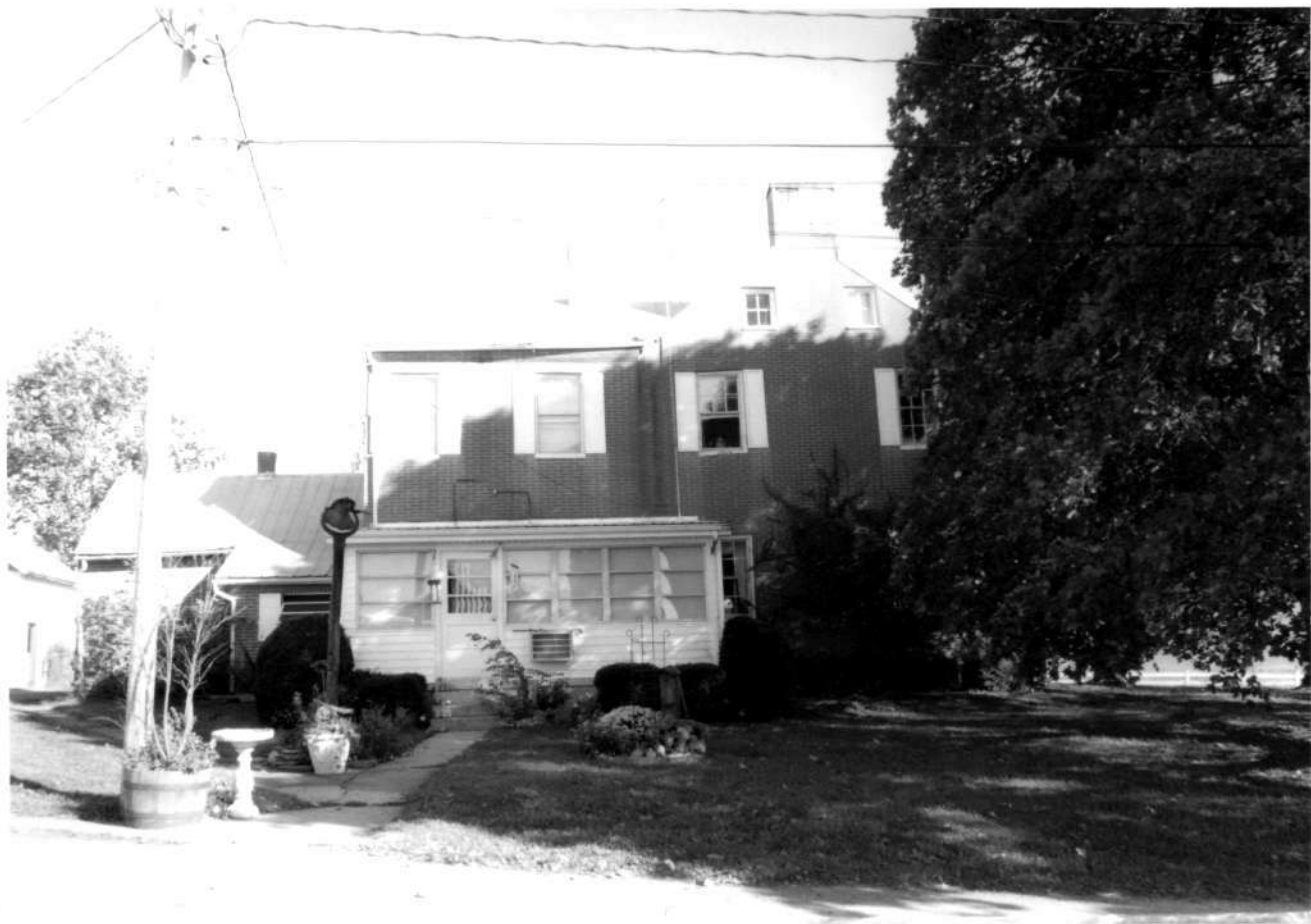
Q OF 15

DWELLING - WEST ELEVATION

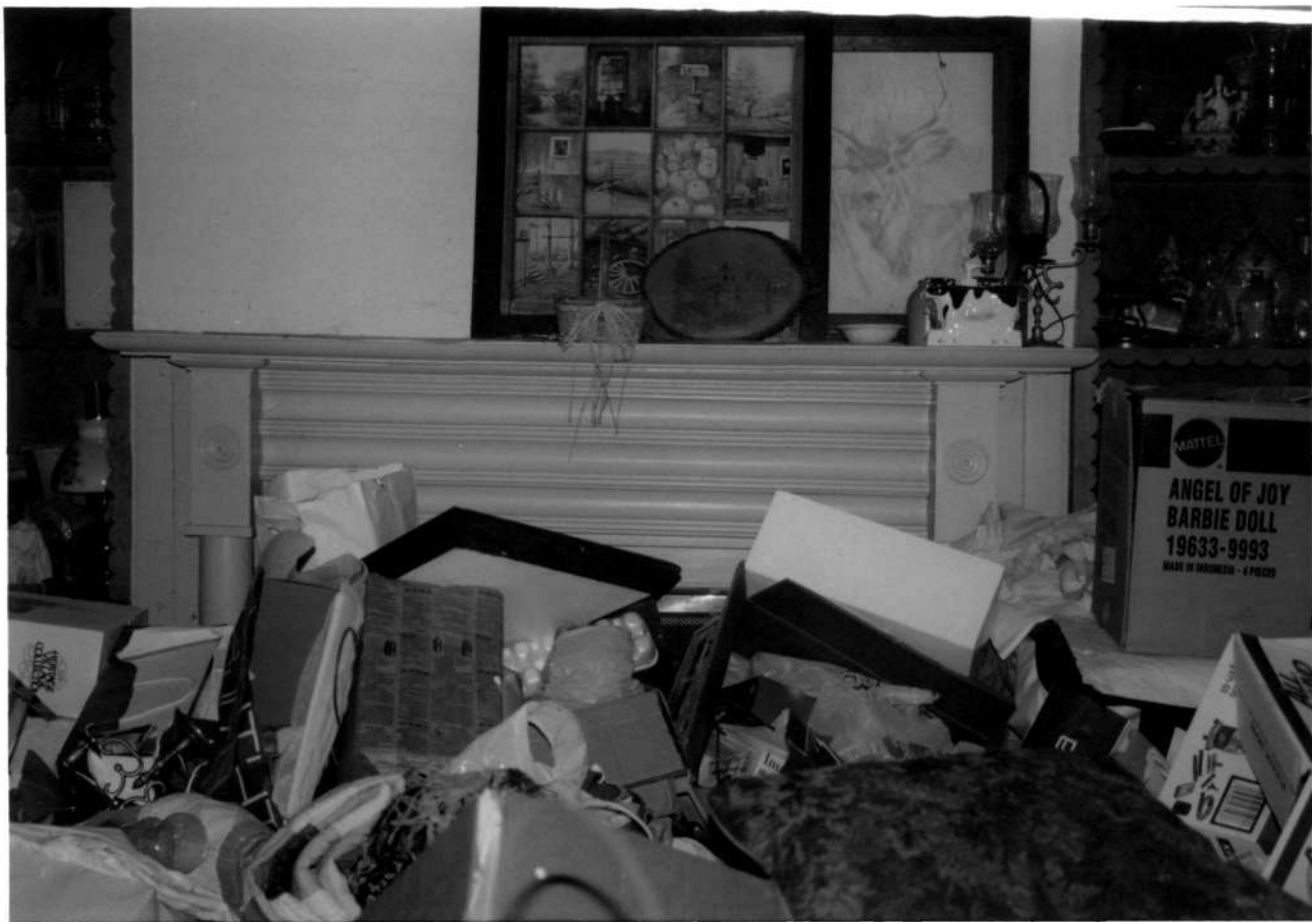
8 OF 15

DWELLING - MANTEL, PARLOR 1

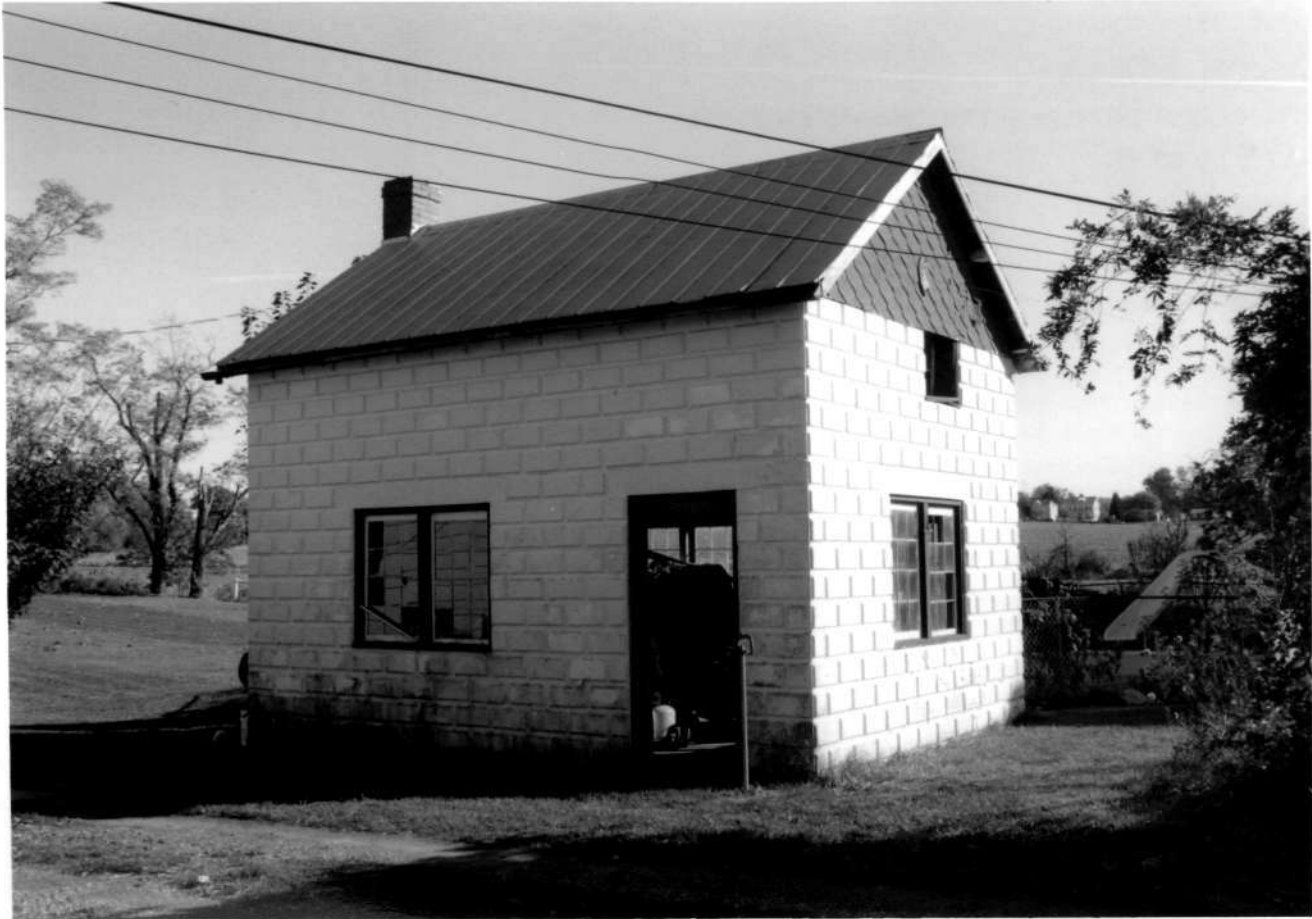
9 of 15

WATER HOUSE - NORTH ELEVATION, LOOKING SE

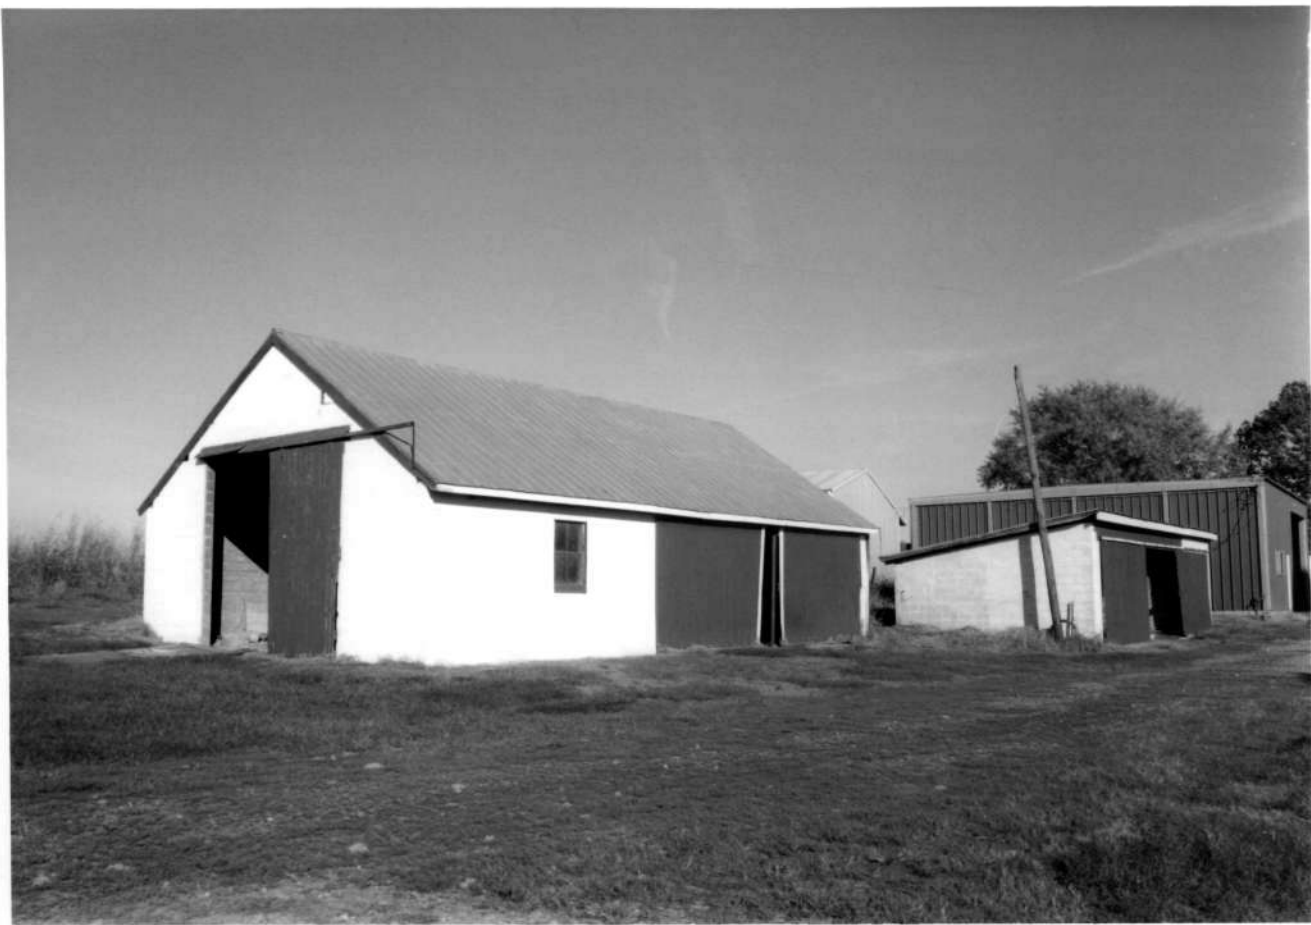
13 OF 15

EQUIPMENT SHEDS 3 + 2 - LOOKING NE

The concrete-block equipment shed was constructed during the late 1940s. The building occupies a rectangular plan and terminates in a shed roof sheathed in corrugated metal. The building faces south and rests on a poured-concrete foundation. Wood, beaded-board, sliding track doors are located on the south elevation. A metal window is located at the eastern end of the south elevation and is covered by a sliding track door. The window type and configuration were not visible. An interior door opening is located on the building's east elevation. The door opening is covered in plywood and leads to a small room, access to which was not possible. A beaded board, sliding track door leads from the room to a shed roofed addition. Square, wood posts support the addition's roof. Roofing materials consist of corrugated metal. The north end of the addition is enclosed in vertical, wood board siding. Equipment shed 2 abuts but is not attached to the shop.

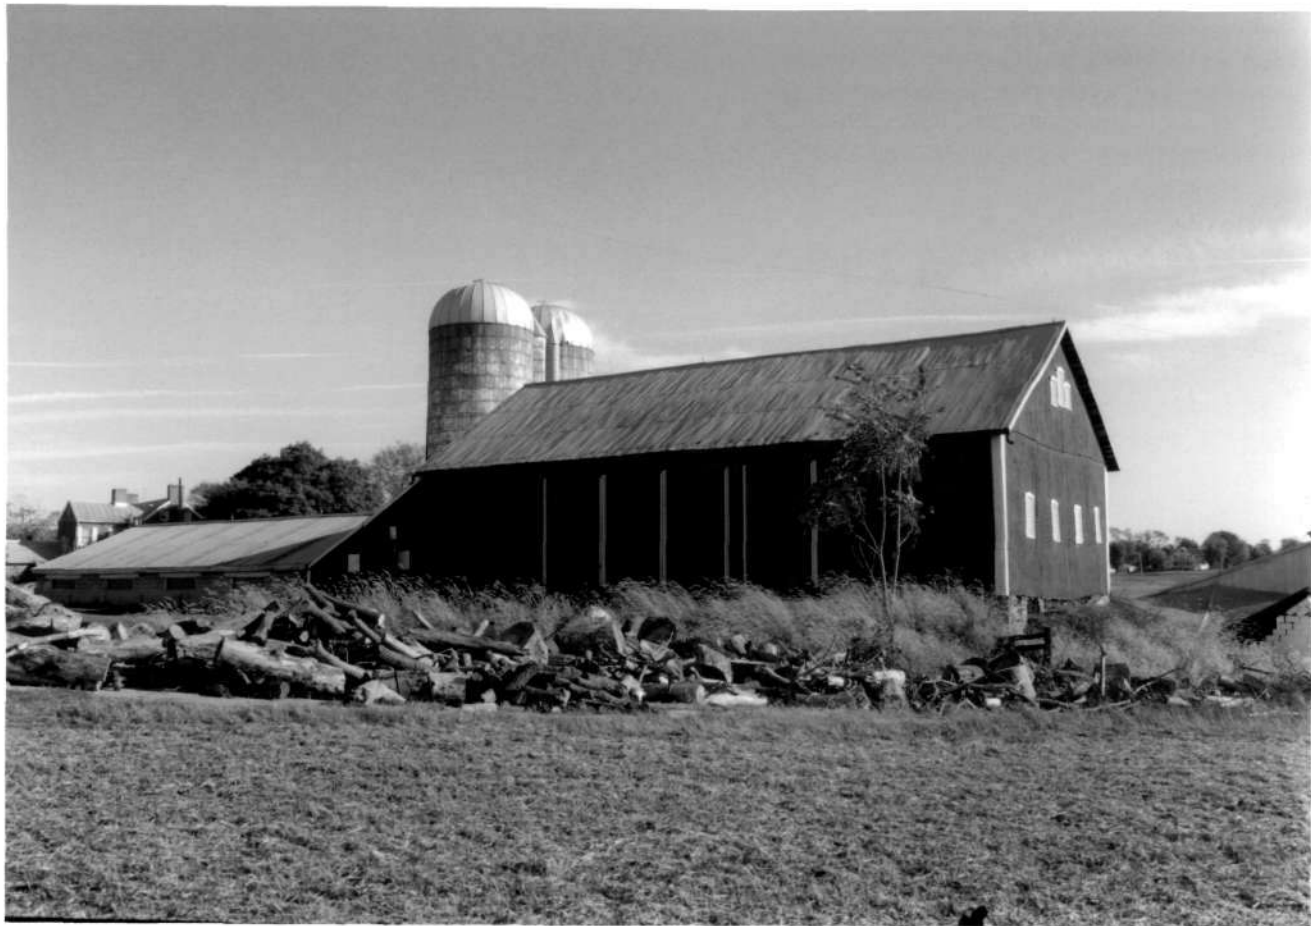
NOV 2005
MD SHPO
BANK BARN & SILOS 1 AND 2 - NORTH ELEVATION WORKINGS
14 OF 15

The ca. 1870 wood-frame bank barn rests on a fieldstone foundation. The barn terminates in a gable roof sheathed in corrugated metal and ornamented with snow geese. The exterior walls are clad with vertical wood siding. The bank (north) elevation features a central sliding wood door. The west elevation contains four ventilation openings surrounded by decorative wood frames and hoods and filled with wooden louvers. Three similar openings are located in the gable; the central opening is larger than the flanking openings.

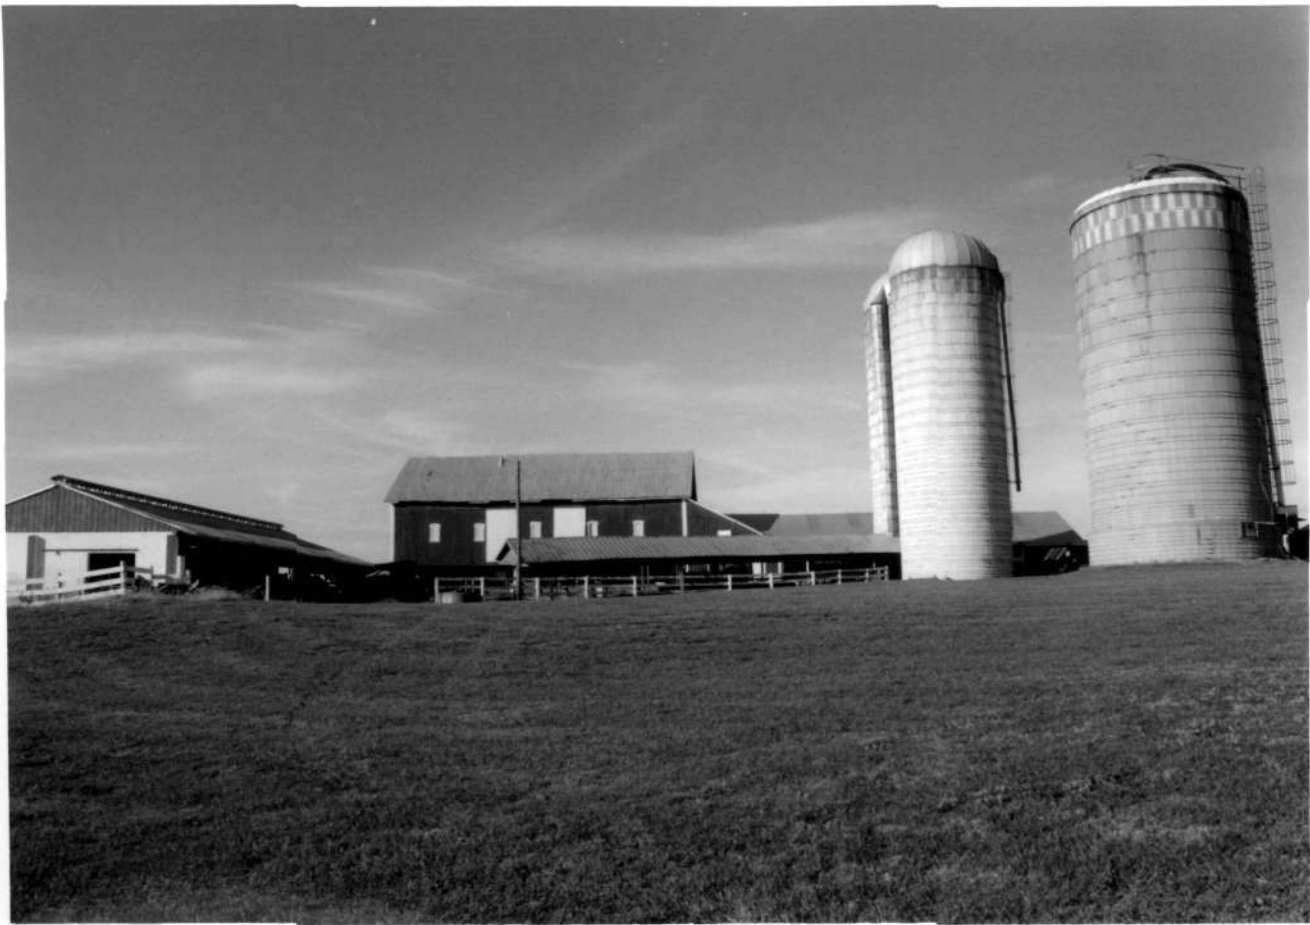
MO SHED
WAFING SHED, BANK BARN, FEEDING TROUGH,
AND SILOS 1, 2, & 3 - NORTH ELEVATION LOOKING S
